**Flood Control Project Maintenance
Levee Inspections**
LMA District Cover Sheet
Spring 2011 Levee Inspection Results

Reclamation District No. 2107 Mossdale Island

Levee Inspection Report By Mile - Spring 2011

Waterway						Bank	Unit Miles	Inspection Start/End	Inspector
Unit No. 01 San Joaquin River						Left	2.37	03/30/2011 03/30/2011	Jim Eto

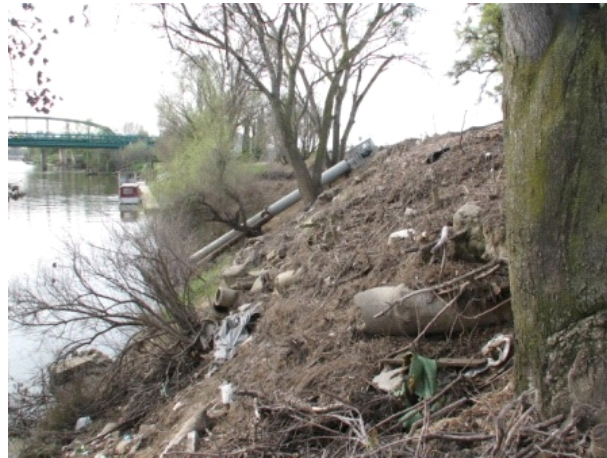
Levee Mile Report Line	1
Start Levee Mile	0.03
End Levee Mile	0.03
Location	Water Side
Category	Earthen Levee
Item	Trim / Thin Trees

Photo of waterside slope. Stumps present from prior tree removal for access and visibility.

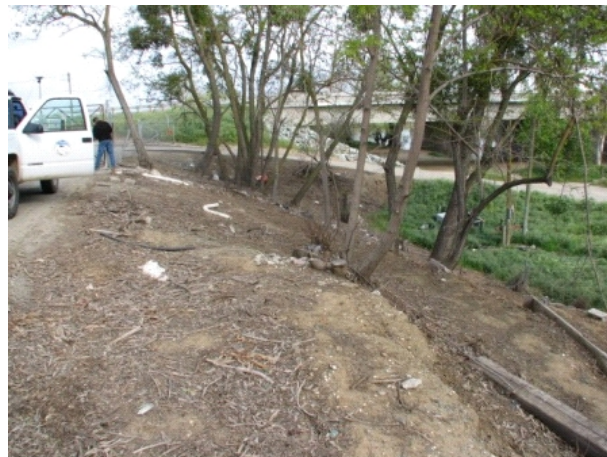
Levee Mile Report Line	2
Start Levee Mile	0.25
End Levee Mile	0.25
Location	Water Side
Category	Earthen Levee
Item	Trim / Thin Trees

Tree stumps present on slope. They were left from prior vegetation removal for access and visibility.

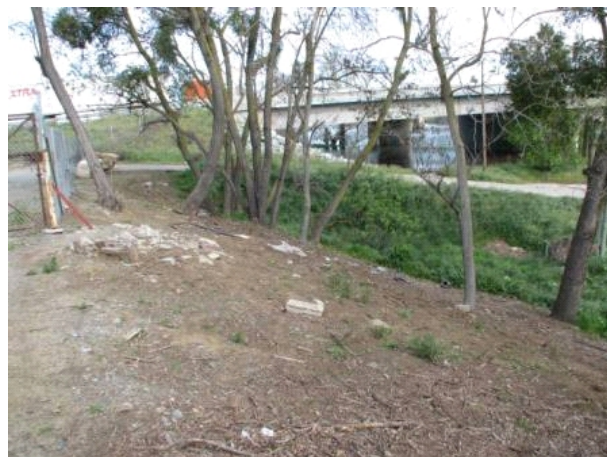
Levee Mile Report Line	4
Start Levee Mile	0.26
End Levee Mile	0.26
Location	Water Side
Category	Earthen Levee
Item	Encroachments

Photo taken 03/30/2011 showing area now free of garbage.

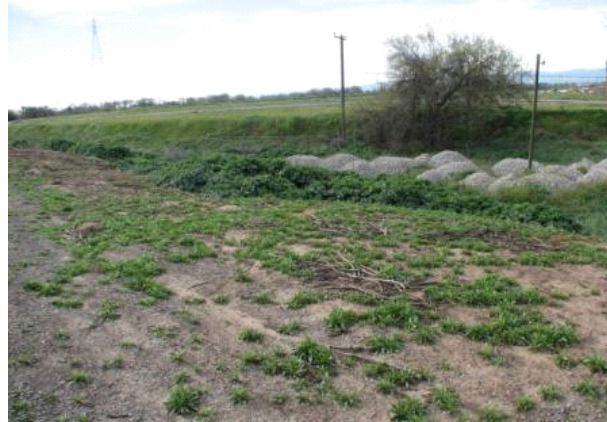
Levee Mile Report Line	5
Start Levee Mile	0.34
End Levee Mile	0.34
Location	Land Side
Category	Earthen Levee
Item	Vegetation
03/30/2011 Thistle has been cleared landside toe is visible	
jeto_s_20110404_352.jpg

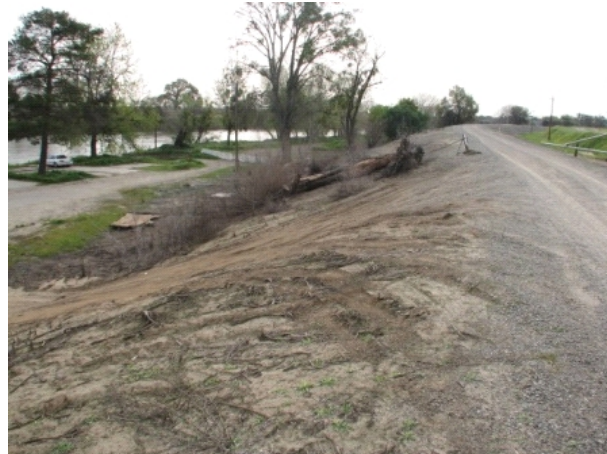
Levee Mile Report Line	7
Start Levee Mile	0.37
End Levee Mile	0.37
Location	Water Side
Category	Earthen Levee
Item	Trim / Thin Trees
Tree stumps and trunks on levee slope. Vehicle traffic on levee slope is an ongoing problem at this location due to the abandoned trailer park, access should be restricted.	
jeto_s_20110301_331.jpg

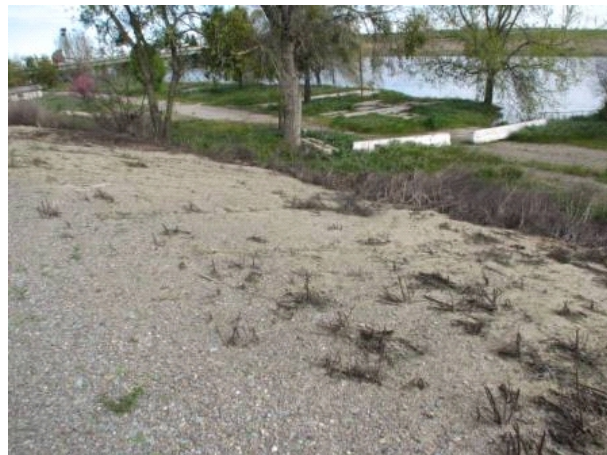
Levee Mile Report Line	9
Start Levee Mile	0.37
End Levee Mile	0.37
Location	Water Side
Category	Earthen Levee
Item	Erosion / Bank Caving
03/30/2011 Erosion from tire tracks has been repaired, no evidence of vehicle track on levee waterside.	
jeto_s_20110407_371.jpg

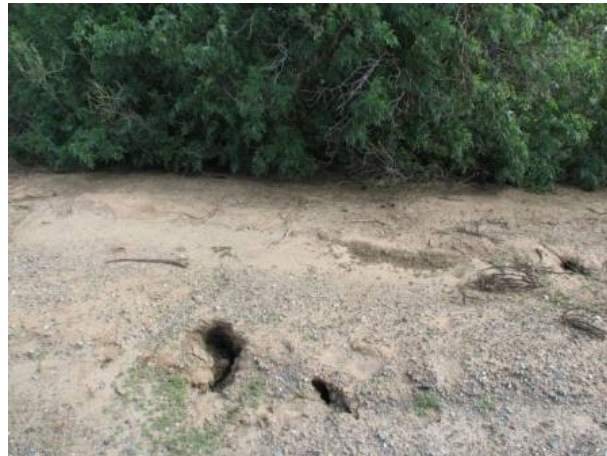
Levee Mile Report Line	10
Start Levee Mile	0.42
End Levee Mile	0.42
Location	Water Side
Category	Earthen Levee
Item	Animal Control
03/30/2011 Animal burrows present, burrows are in close proximity to Elderberry bush	
jeto_s_20110404_354.jpg

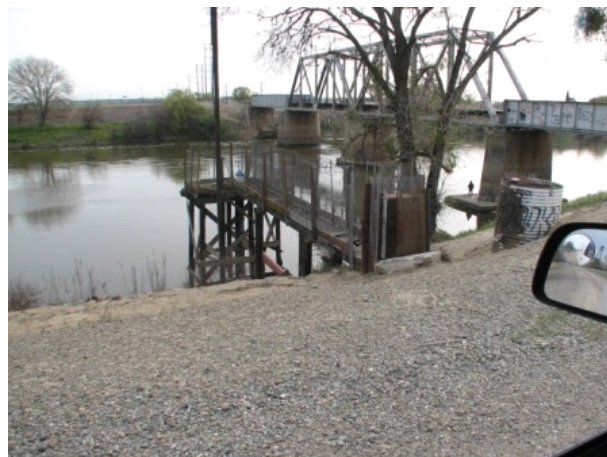
Levee Mile Report Line	11
Start Levee Mile	0.68
End Levee Mile	0.68
Location	Crown
Category	Earthen Levee
Item	Encroachments
Irrigation intake pipe runs through the base of the levee. Stand pipes on waterside and landside. A Butterfly valve is located near waterside slope.	
jeto_s_20110301_332.jpg

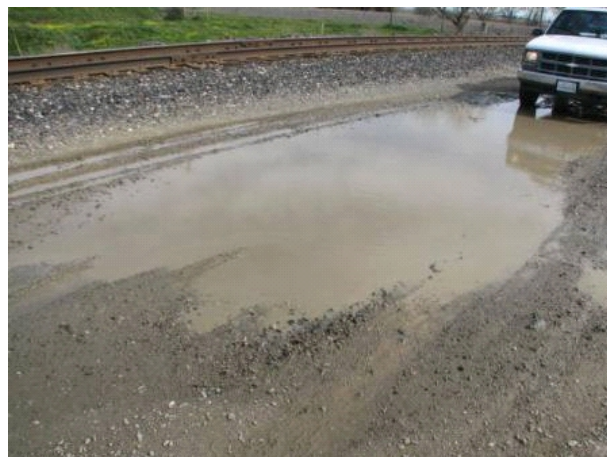
Levee Mile Report Line	12
Start Levee Mile	0.75
End Levee Mile	0.75
Location	Crown
Category	Earthen Levee
Item	Crown Surface / Depressions / Rutting
03/30/2011 Depression in crown is collecting water, it appears that the water draining from the low spot is the cause of the bank erosion at the same levee mile.	
jeto_s_20110404_356.jpg

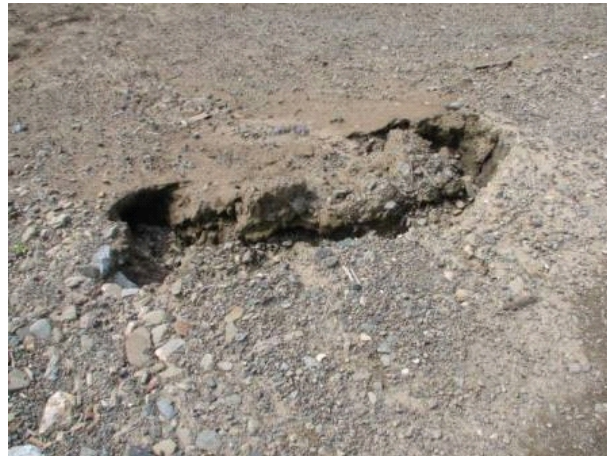
Levee Mile Report Line	13
Start Levee Mile	0.75
End Levee Mile	0.75
Location	Water Side
Category	Earthen Levee
Item	Erosion / Bank Caving

03/30/2011 Erosion on landside appears to be caused by drainage from depression in levee crown at same levee mile (0.75).

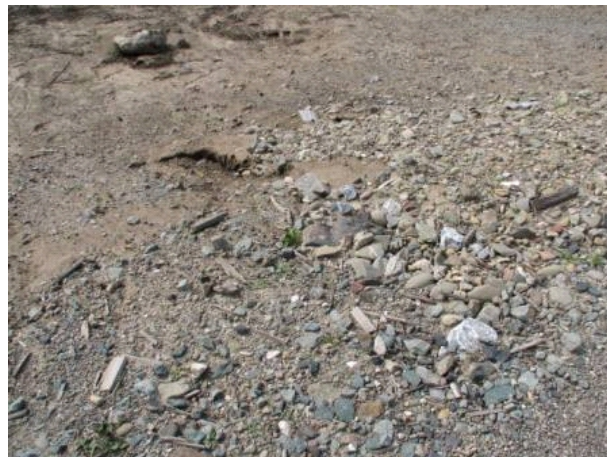
Levee Mile Report Line	13
Start Levee Mile	0.75
End Levee Mile	0.75
Location	Water Side
Category	Earthen Levee
Item	Erosion / Bank Caving

03/30/2011 Minor erosion on landside

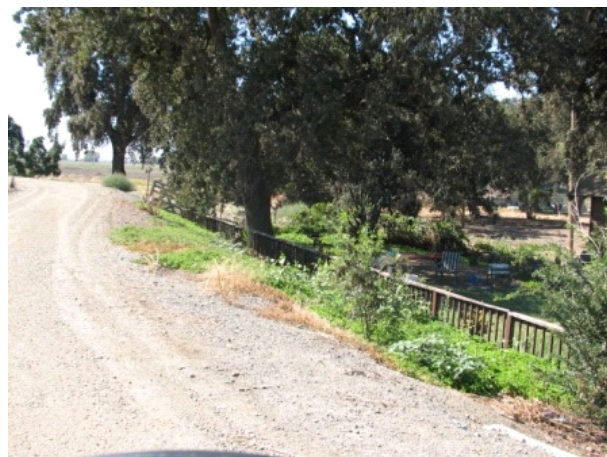
Levee Mile Report Line	16
Start Levee Mile	1.24
End Levee Mile	1.24
Location	Land Side
Category	Earthen Levee
Item	Encroachments

Fall 2009 photo of landscape planting on landside levee slope and a 3-ft yard fence at the levee toe.

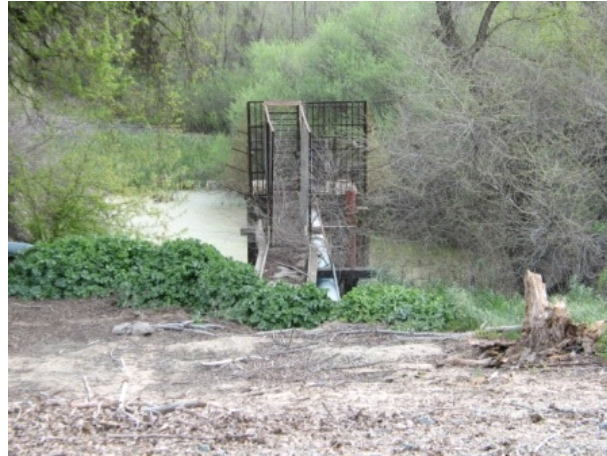
Levee Mile Report Line	17
Start Levee Mile	1.49
End Levee Mile	1.49
Location	Crown
Category	Earthen Levee
Item	Encroachments
Irrigation intake pipe through levee free board.	
jeto_s_20110301_334.jpg

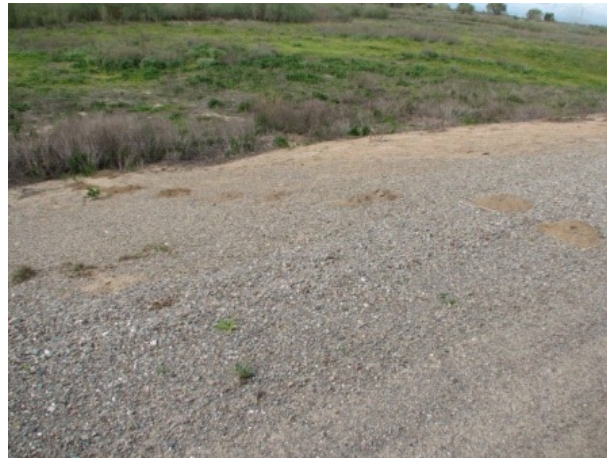
Levee Mile Report Line	1
Start Levee Mile	0.14
End Levee Mile	0.14
Location	Crown
Category	Earthen Levee
Item	Animal Control
Animal burrowing activity on levee slope.	
jeto_s_20110301_336.jpg

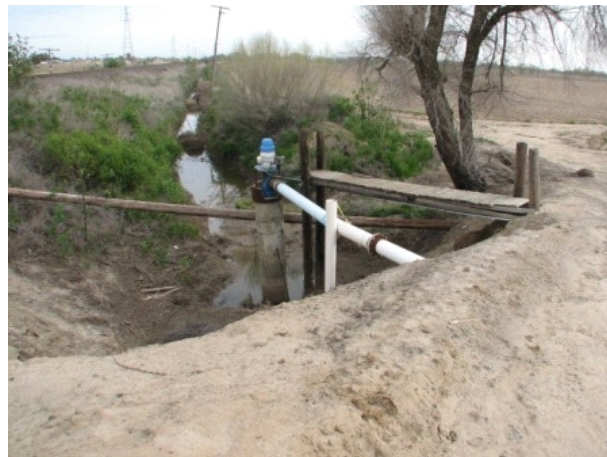
Levee Mile Report Line	2
Start Levee Mile	0.55
End Levee Mile	0.55
Location	Crown
Category	Earthen Levee
Item	Encroachments
Drainage discharge pump. Steel pipe penetrates levee freeboard. No flapgate on waterside. No closure device.	
jeto_s_20110301_337.jpg

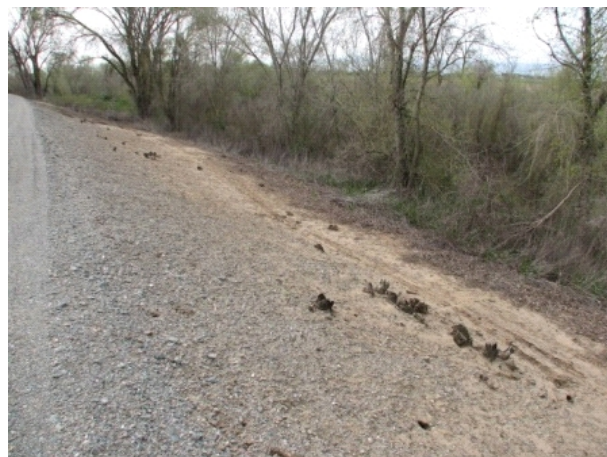
Levee Mile Report Line	3
Start Levee Mile	0.84
End Levee Mile	0.84
Location	Water Side
Category	Earthen Levee
Item	Trim / Thin Trees
Tree stumps on levee slope.	
jeto_s_20110301_339.jpg

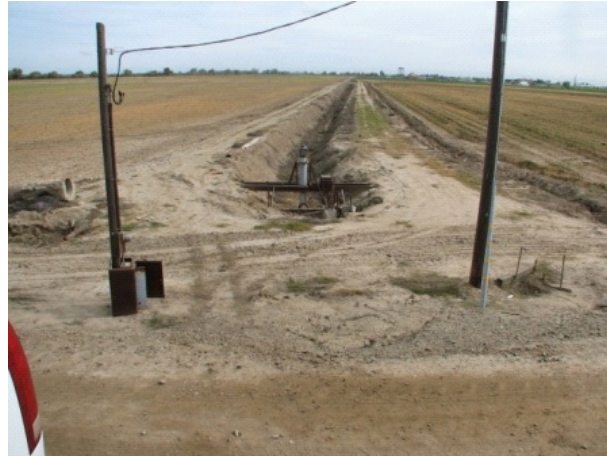
Levee Mile Report Line	5
Start Levee Mile	1.53
End Levee Mile	1.53
Location	Crown
Category	Earthen Levee
Item	Encroachments

Drainage discharge pump inoperable. Parallel gravity drainage to Paradise Cut.

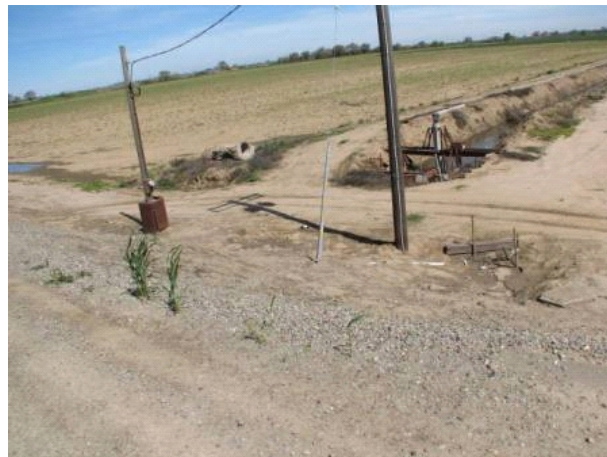
Levee Mile Report Line	5
Start Levee Mile	1.53
End Levee Mile	1.53
Location	Crown
Category	Earthen Levee
Item	Encroachments

03/30/2011 photo of Unit 2 gravity drain
